AUDIT REPORT

Proyecto Pájaro
JJCL-001-MEX-15102024 ALVARADO, VERACRUZ DE IGNACIO
DE LA LLAVE, MÉXICO
Juan José Cervantes Lara
Veracruz, México

10 february, 2025

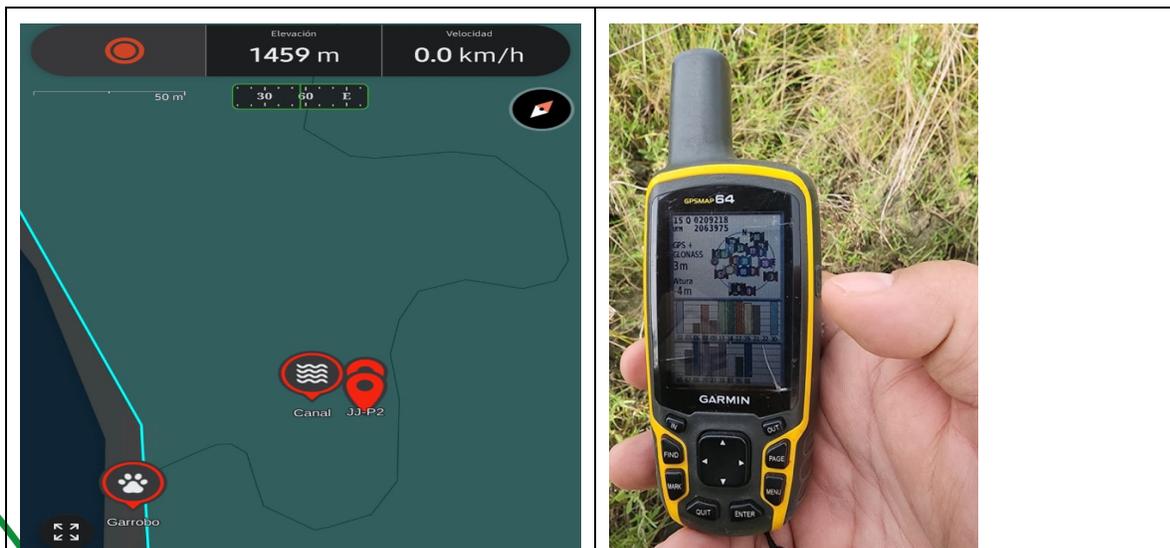
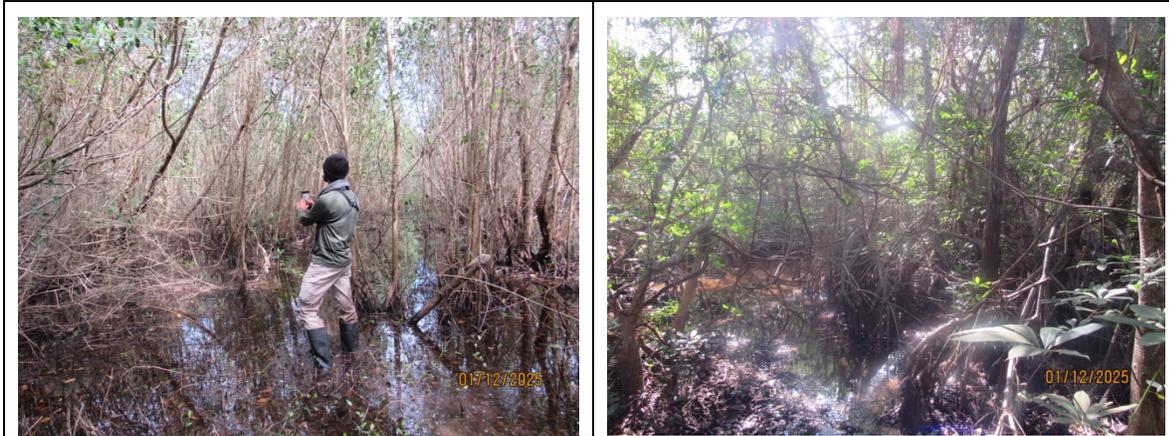
II.2.1. Evidence and results of the “Validation of the project area” activity

Activities declared in the PSF	Compliance	Audit comments
Validation of the project area	Yes	The project boundaries were confirmed and surveyed in accordance with the KMZ polygon using a GPS device and global positioning applications.
Rehabilitation of the water network	Partially	In the PSF, the Project Developer stated that 6,592.5 m ³ of natural and artificial channels were excavated, which are essential for restoring hydrological flow and promoting the natural regeneration of the ecosystem. A field inspection was carried out using a rowboat to verify the presence and condition of these channels. The presence of the channels was confirmed; however, they were found to need maintenance, as their condition was not optimal.
Implementation of firebreaks and perimeter fencing	Partially	In the PSF, the Project Developer stated that 5.82 km of firebreaks and perimeter fences were implemented to prevent wildfires and protect the reforested areas from potential disturbances. During the audit activities, perimeter fences were found to be in poor condition, with fallen wire or missing posts. Regarding the firebreaks, they have not received maintenance since their initial construction, and are therefore deteriorated, with potentially very

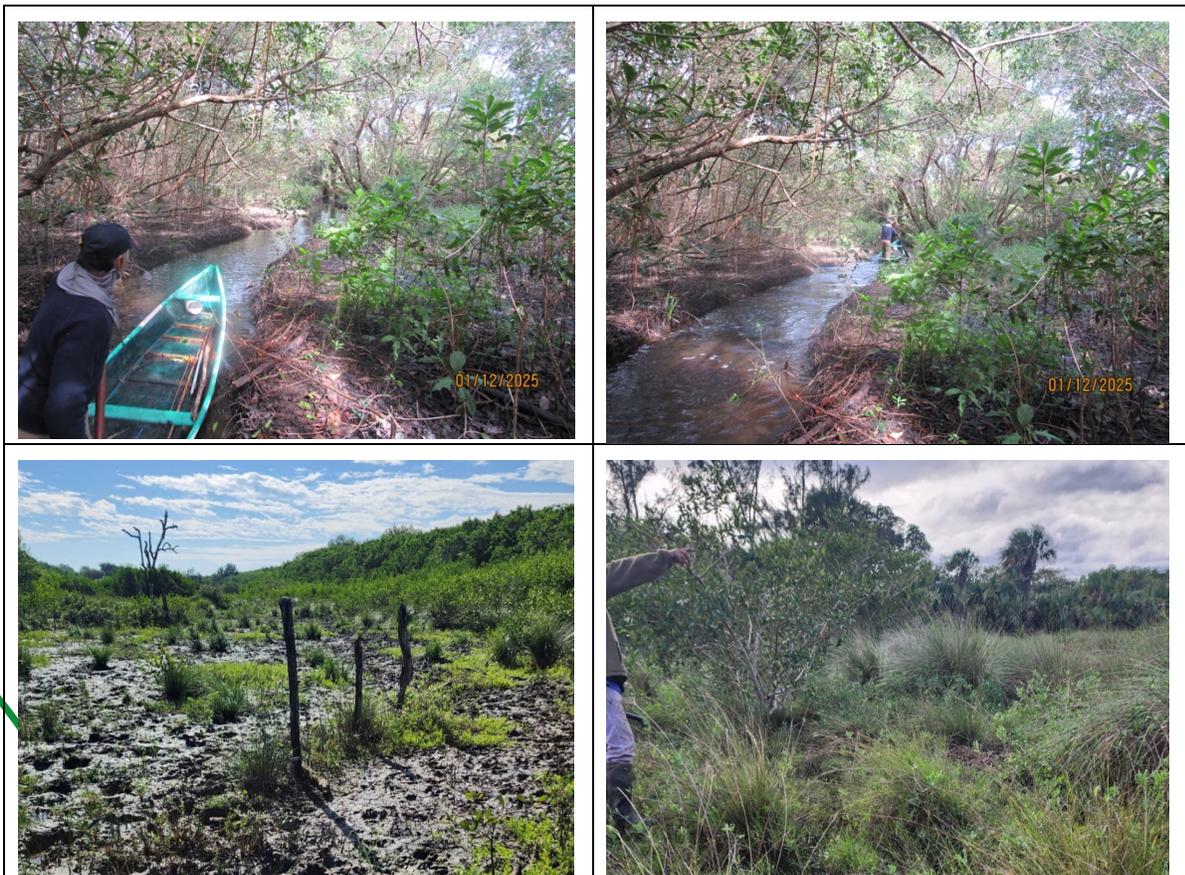
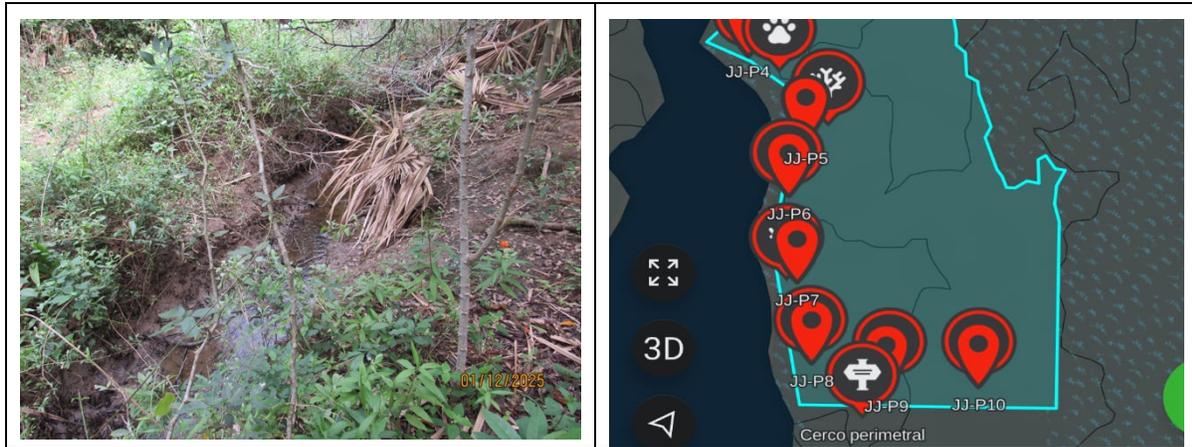
II.2.2. Evidence and results of the “Rehabilitation of the water network” and the “Implementation of firebreaks and perimeter fencing” activities

Activities declared in the PSF	Compliance	Audit comments
		low or no functional utility. As a result, it was recommended that these be rehabilitated.
Mangrove reforestation	Yes	<p>In the PSF, the Project Developer stated that a total of 85,240 plants were established, distributed as follows:</p> <ul style="list-style-type: none"> • Black mangrove (<i>Avicennia germinans</i>): 50,600 individuals (59%) • White mangrove (<i>Laguncularia racemosa</i>): 33,540 individuals (39%) • Red mangrove (<i>Rhizophora mangle</i>): 1,100 individuals (1%) <p>Data collection was carried out for the sampling of individuals and the evaluation of carbon capture within the mangrove restoration project. A total of 10 sampling units were established, representing a sampling intensity of 0.5% of the total project area.</p>

If the project seeks to generate additional types of credits (beyond carbon credits), it is recommended to perform maintenance on the channels, firebreaks, and perimeter fences to ensure their proper functioning and compliance with aOCP eligibility criteria.

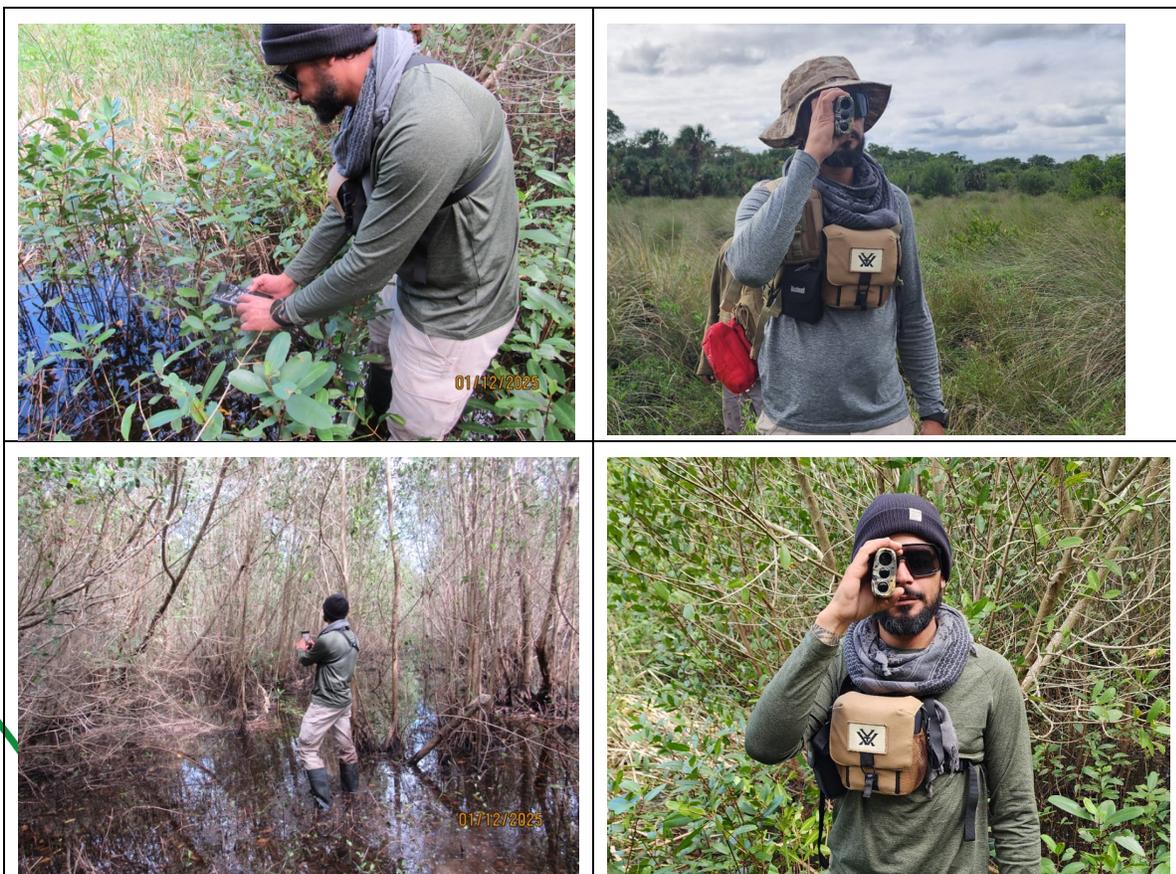
II.2.3. Evidence and results of the “Mangrove reforestation” activity

A total of 10 sampling units were established for the *Proyecto Pájaro*, representing a sampling intensity of 0.5% of the total project area.
